THE PREVENTION OF ELECTRICAL BREAKDOWN
AND ELECTROSTATIC VOLTAGE PROBLEMS
IN THE SPACE SHUTTLE AND ITS PAYLOADS

PART II - DESIGN GUIDES
AND OPERATIONAL CONSIDERATIONS

National Aeronautics and Space Administration
LYNDON B. JOHNSON SPACE CENTER

February 3, 1975

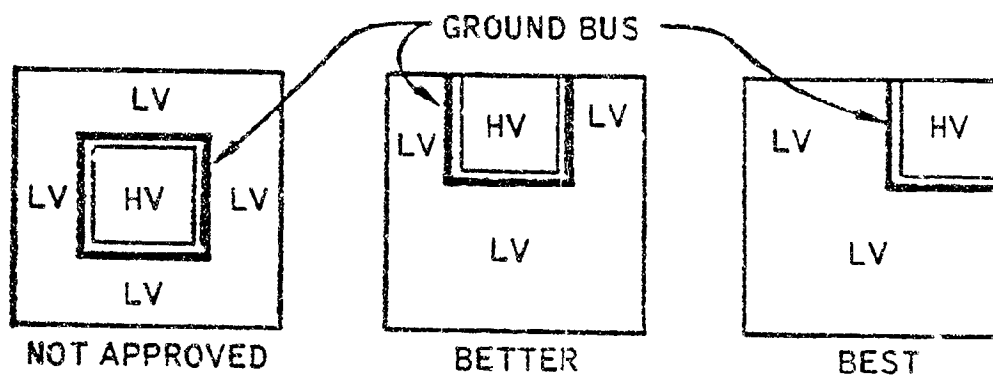
Figure 2-1.- Common-boundary high- and low-voltage circuits.

The equipment should be packaged in such a way that all the high-voltage wiring is isolated or shielded from other circuits to avoid transfer of energy. One approach is to enclose the entire high-voltage circuit in a conducting envelope with just a shielded coaxial cable to the circuit it supplies.

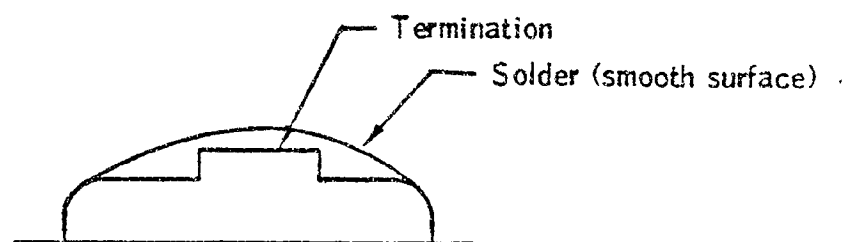
Figure 2-2.- Acceptable soldered termination.

Proper soldering can reduce the electric field intensity and thus reduce the chances of corona. Also, sharp points left by improper soldering can cause tears in the insulation, which, of course, can lead to insulation breakdown. Some sketches of acceptable and unacceptable soldered terminations are shown in figures 5-2 to 5-4.

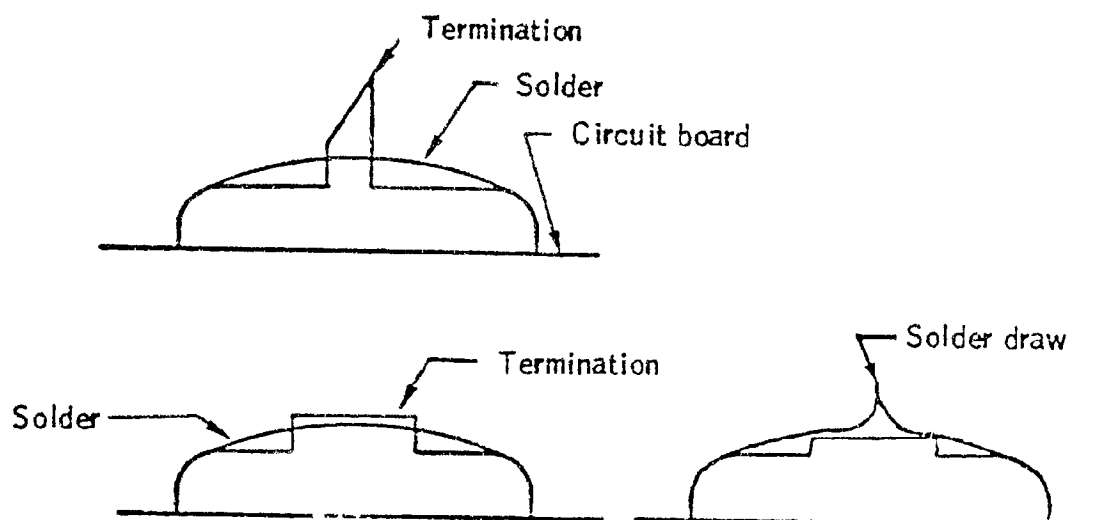
Figure 2-3.- Unacceptable soldered terminations.

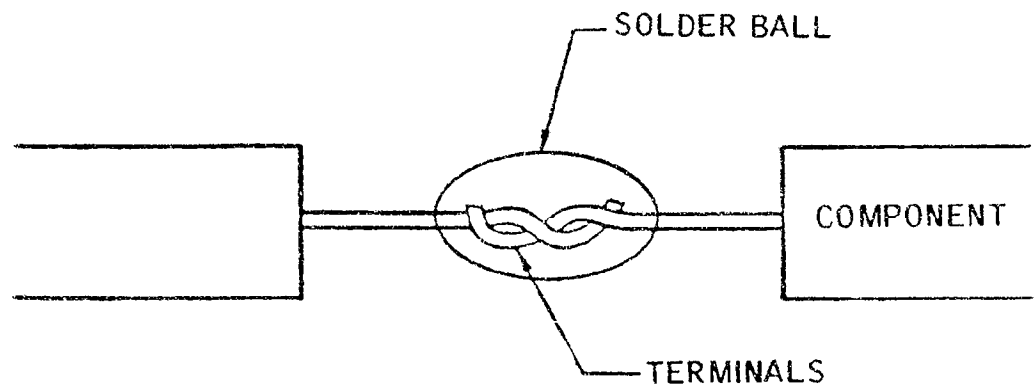
Figure 2-4.- Acceptable components interconnection.

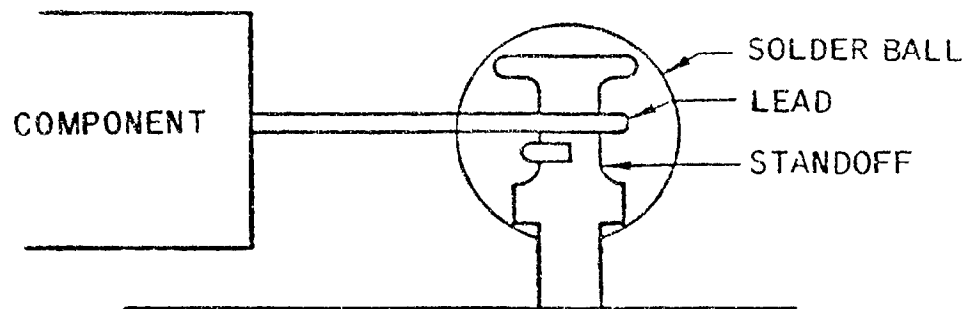
Figure 2-5.- Acceptable standoff connection.

Standoffs and feedthroughs should be solder-balled as shown in figure 5-5. This will probably require a waiver from the NASA solder specifications. The solder ball is made after the connection is soldered per the appropriate NASA specification. Dunbar (ref. 12) states that "The radius of the solder ball facing the ground plane should be at least $1/6$ of the value of the spacing between the solder ball and ground plane or

adjacent high voltage circuit. This low ratio decreases the voltage gradient at the surface of the solder ball and decreases the probability of corona. When large spacings are involved the solder ball should have at least 3.1 millimeters (0.125 inch) diameter. These solder balls must be properly secured to eliminate any dynamic vibration and acoustic problems."

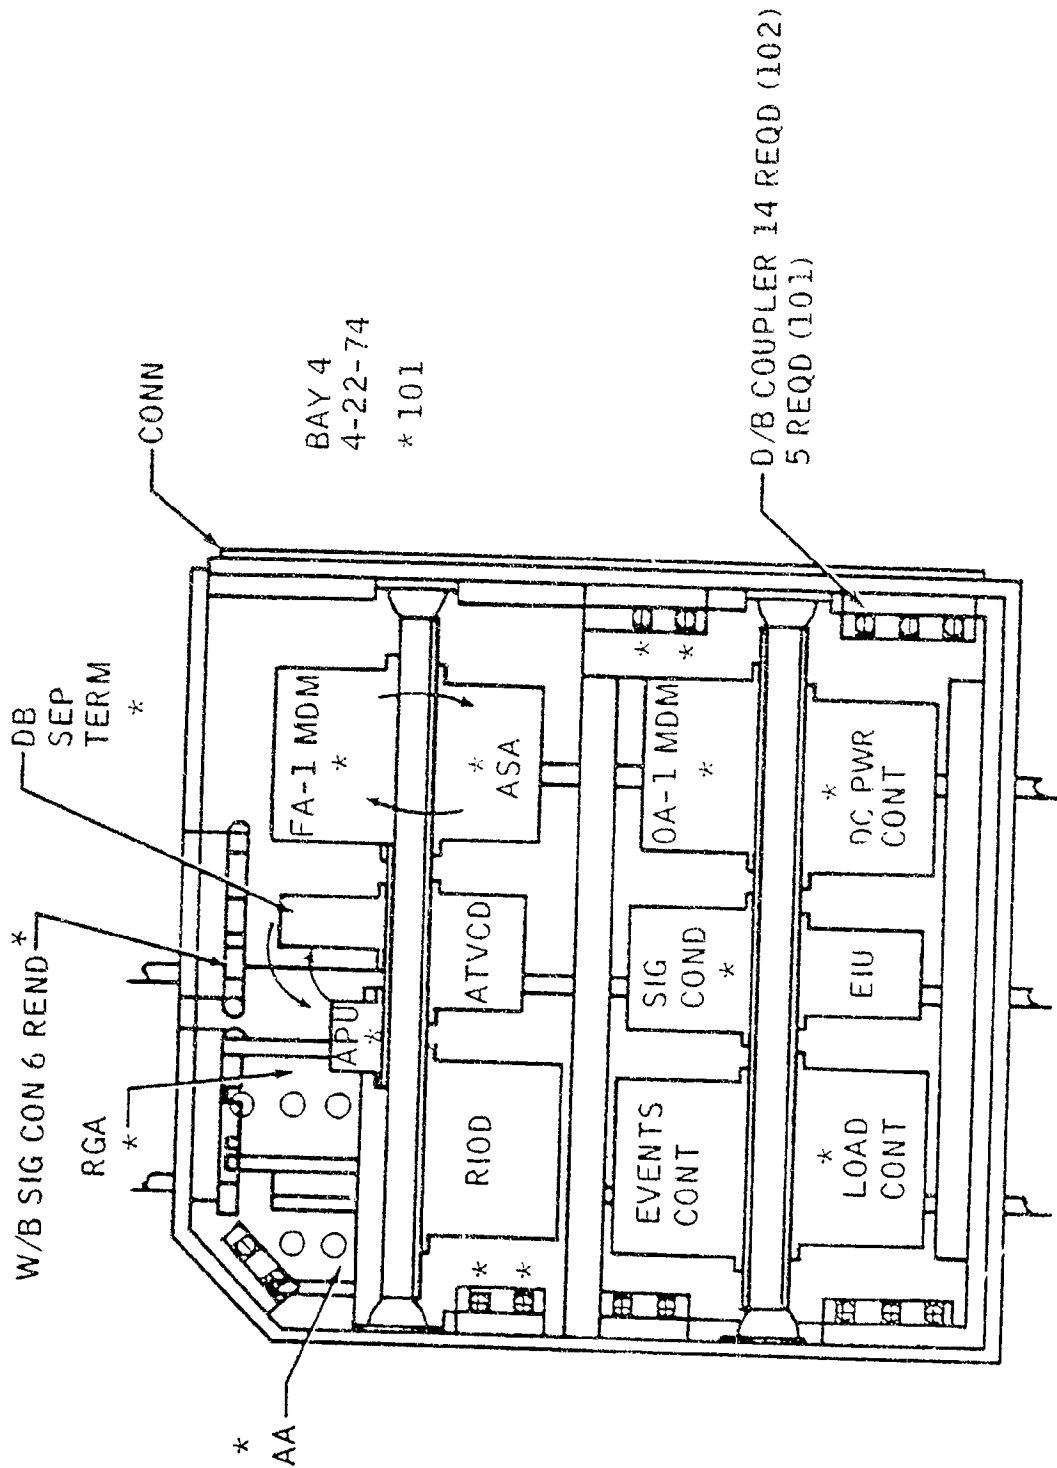
Figure 2-7.- Electronic equipment contained in bay 4.

The next question is: How hot will it be for the electronics in bays 4, 5, and 6? If there are no plans for cooling the bay, then the temperature could become quite high. At high temperatures (above 500° F), rapid deterioration of the insulation sets in as described in section 3.4.7.3. When this happens, corona will set in. Besides accelerating the degradation of the insulation, the corona could generate false bits of data for the computer. Eventually total voltage breakdown would occur. The false bits of data could possibly be screened out by clever software, but total voltage breakdown would be disastrous.

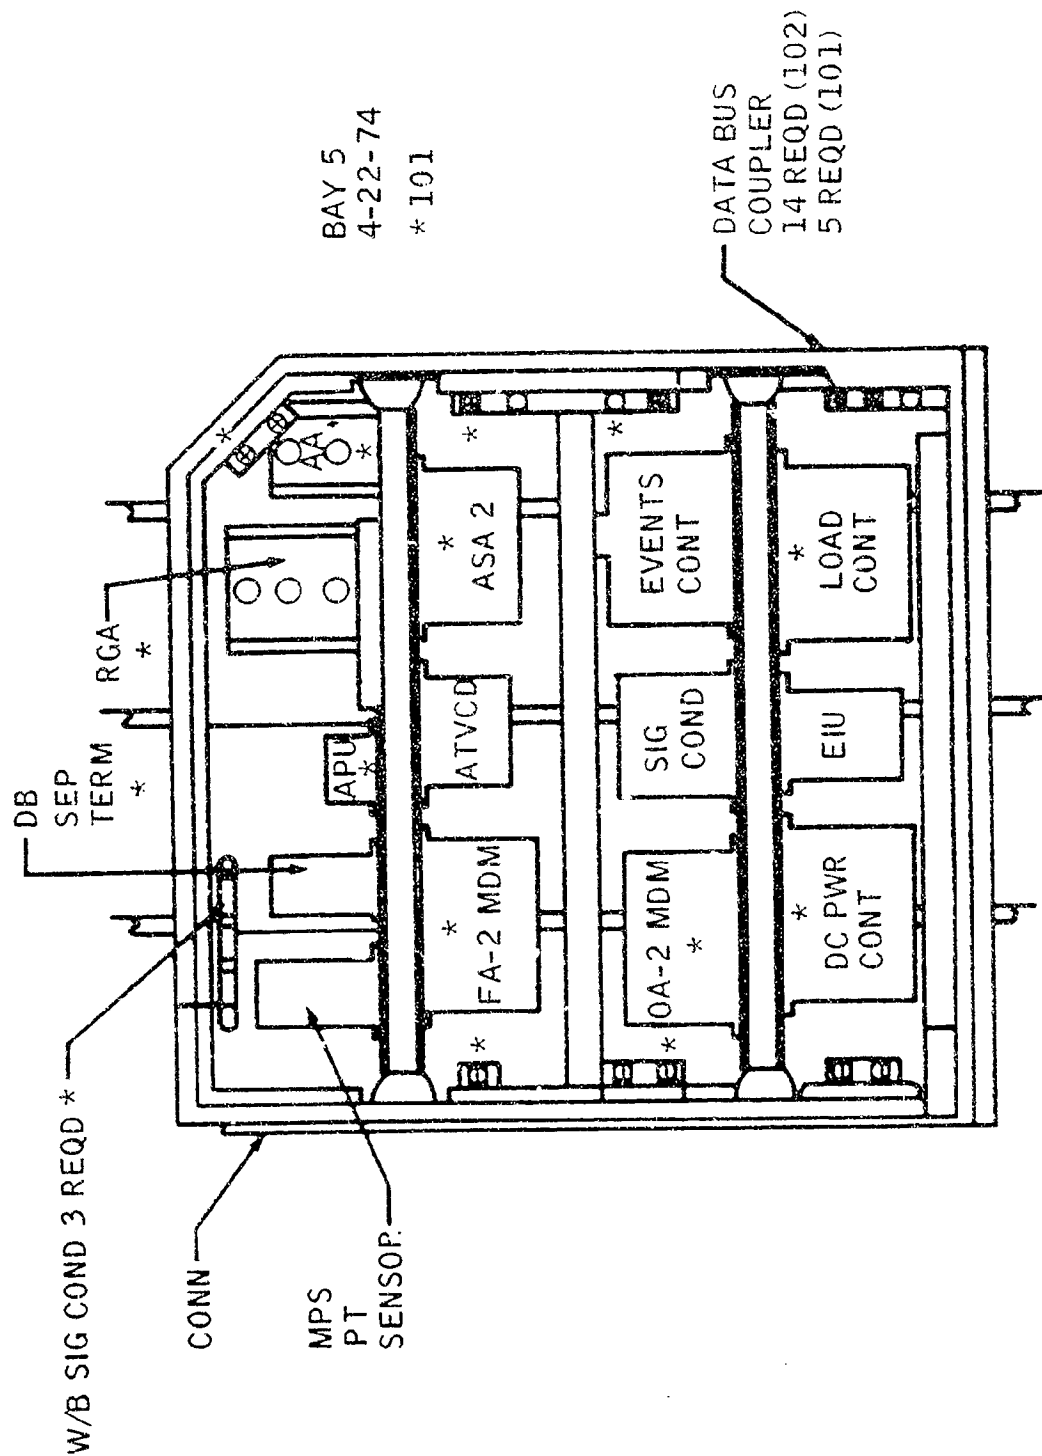
Figure 2-8.- Electronic equipment contained in bay 5.

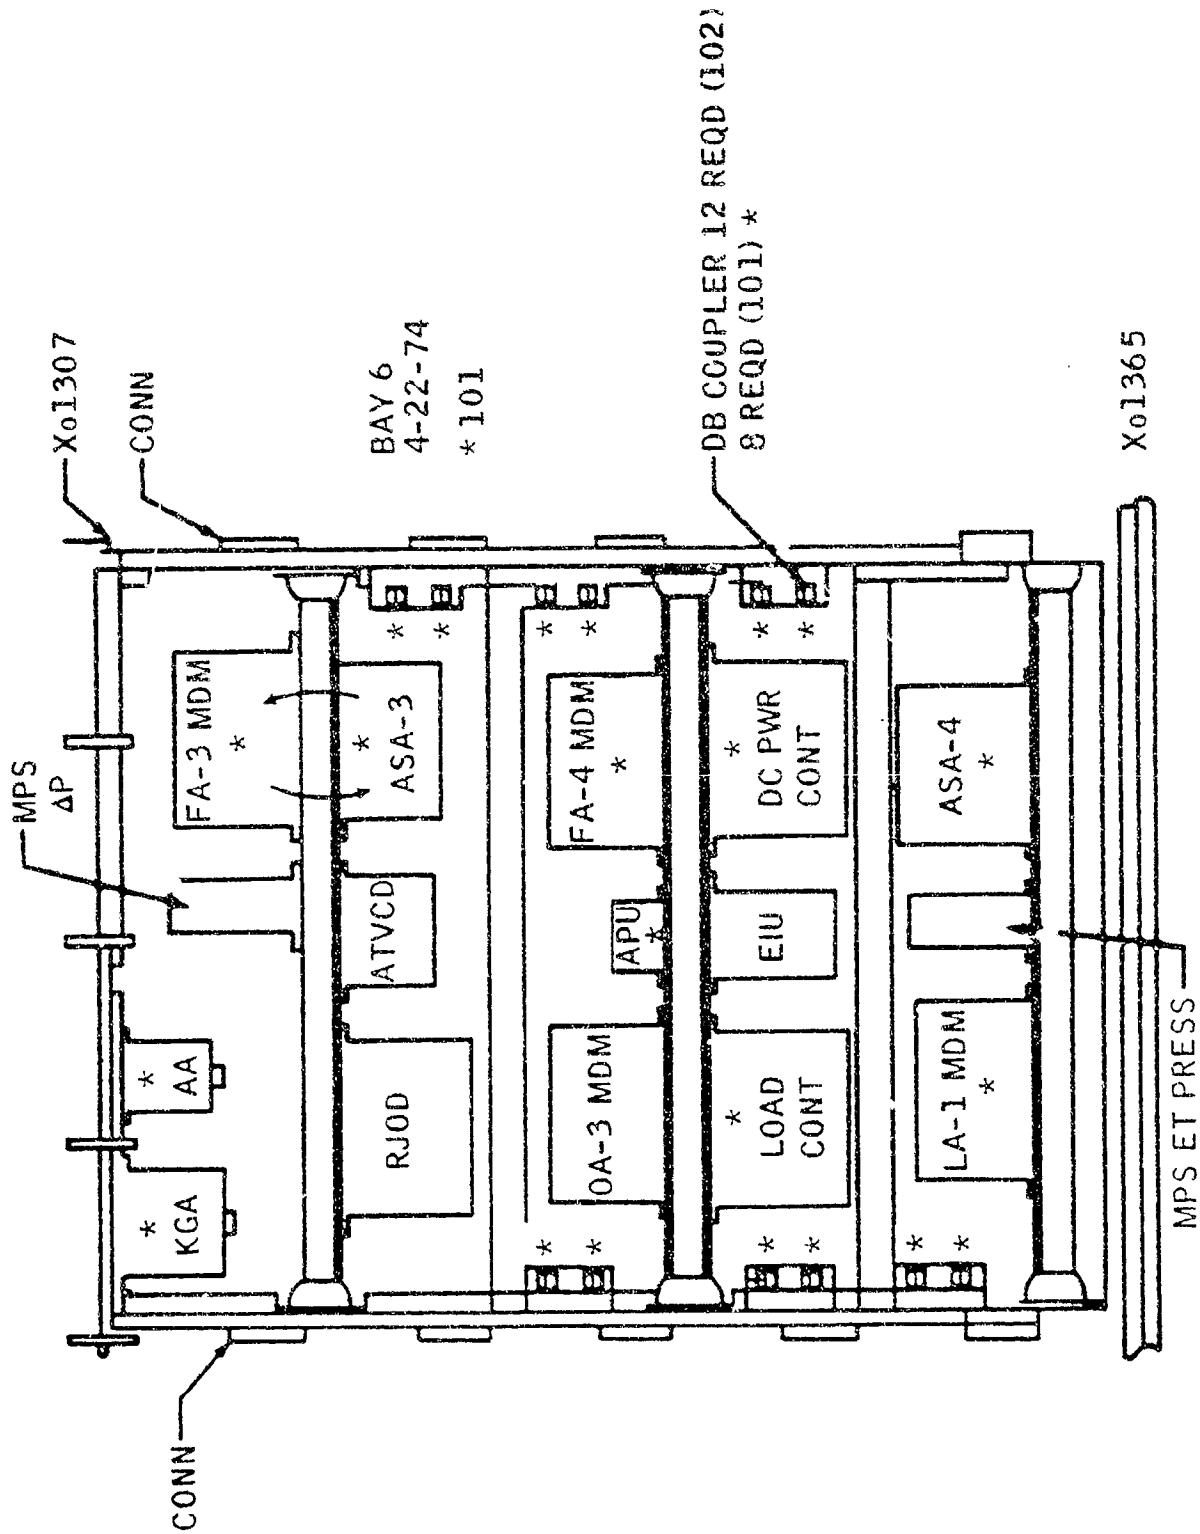
Figure 2-9.- Electronic equipment contained in bay 6.

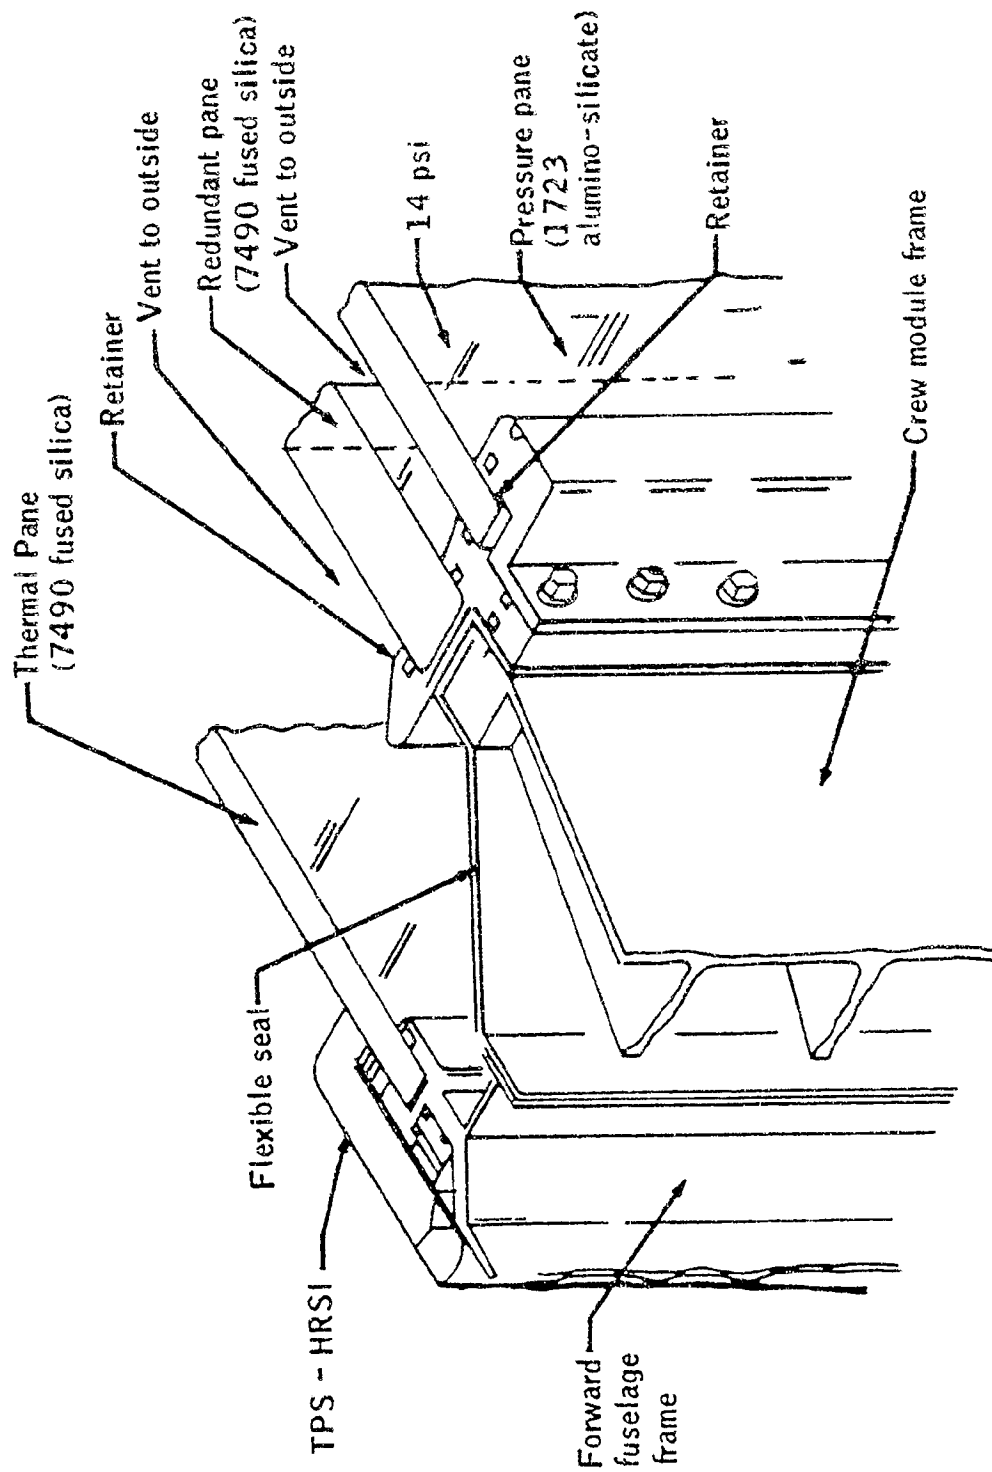
Figure 3-1.- Orbiter windshield construction.

- 3.1.2.1 Puncture problems.- The orbiter windshield does not have a deicer. It is felt that because of its unique flight plan there will be no condensation on the windshields. During launch, the air leaking out will be warmer than the ambient. In orbit, the slow leakage will not cause condensation. The windshield is expected to be hot up to an hour after landing, so no condensation is expected during reentry or landing.

The absence of a deicer almost eliminates the possibility of puncture. When the windshield discharges, it will almost certainly do so to the air frame.

- 3.1.2.2 Visibility and rf noise problems.- Because the windshield is a nonconductor, there will almost certainly be streamer effects during the launch period. These streamers will probably be fairly energetic and could cause some visibility problems and almost certainly will cause some rf noise problems. If this rf noise is coupled into the data-transmission lines or the communications, the results could be serious. With airplanes, a transparent conductive coating is put onto the windshield to increase the conductivity. Any coating on the windshield of the orbiter, however, would be burned off during reentry.

However, there may be no streamer discharge problem from the windshield during reentry because of the extreme heat. If this were the case and protection against streamers were a problem only during the launch phase, then a coating could be applied before each launch. Of course, the coating should be chosen to obviate deleterious effects as a result of its burning off during reentry.
